NACA RM E55H02

RESEARCH MEMORANDUM

FACTORS THAT AFFECT OPERATIONAL RELIABILITY
OF TURBOJET ENGINES

By Lewis Laboratory Staff

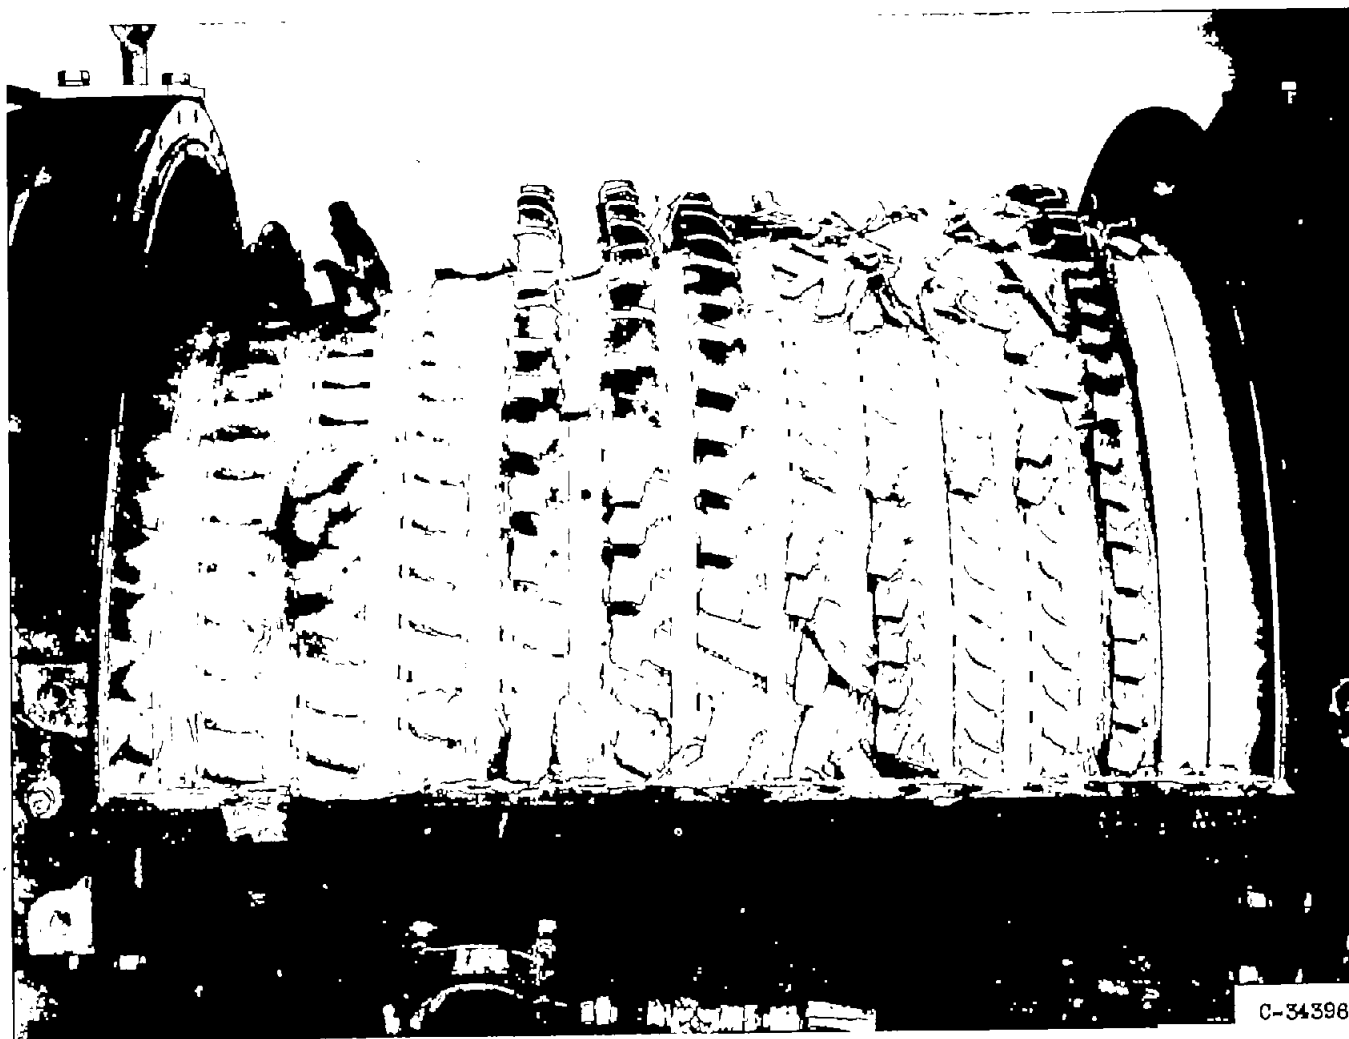
Figure 6. - Compressor damage resulting from bearing failure in oil interruption tests. Same engine as in figures 5 and 7. (From appendix B, ref. 1.)

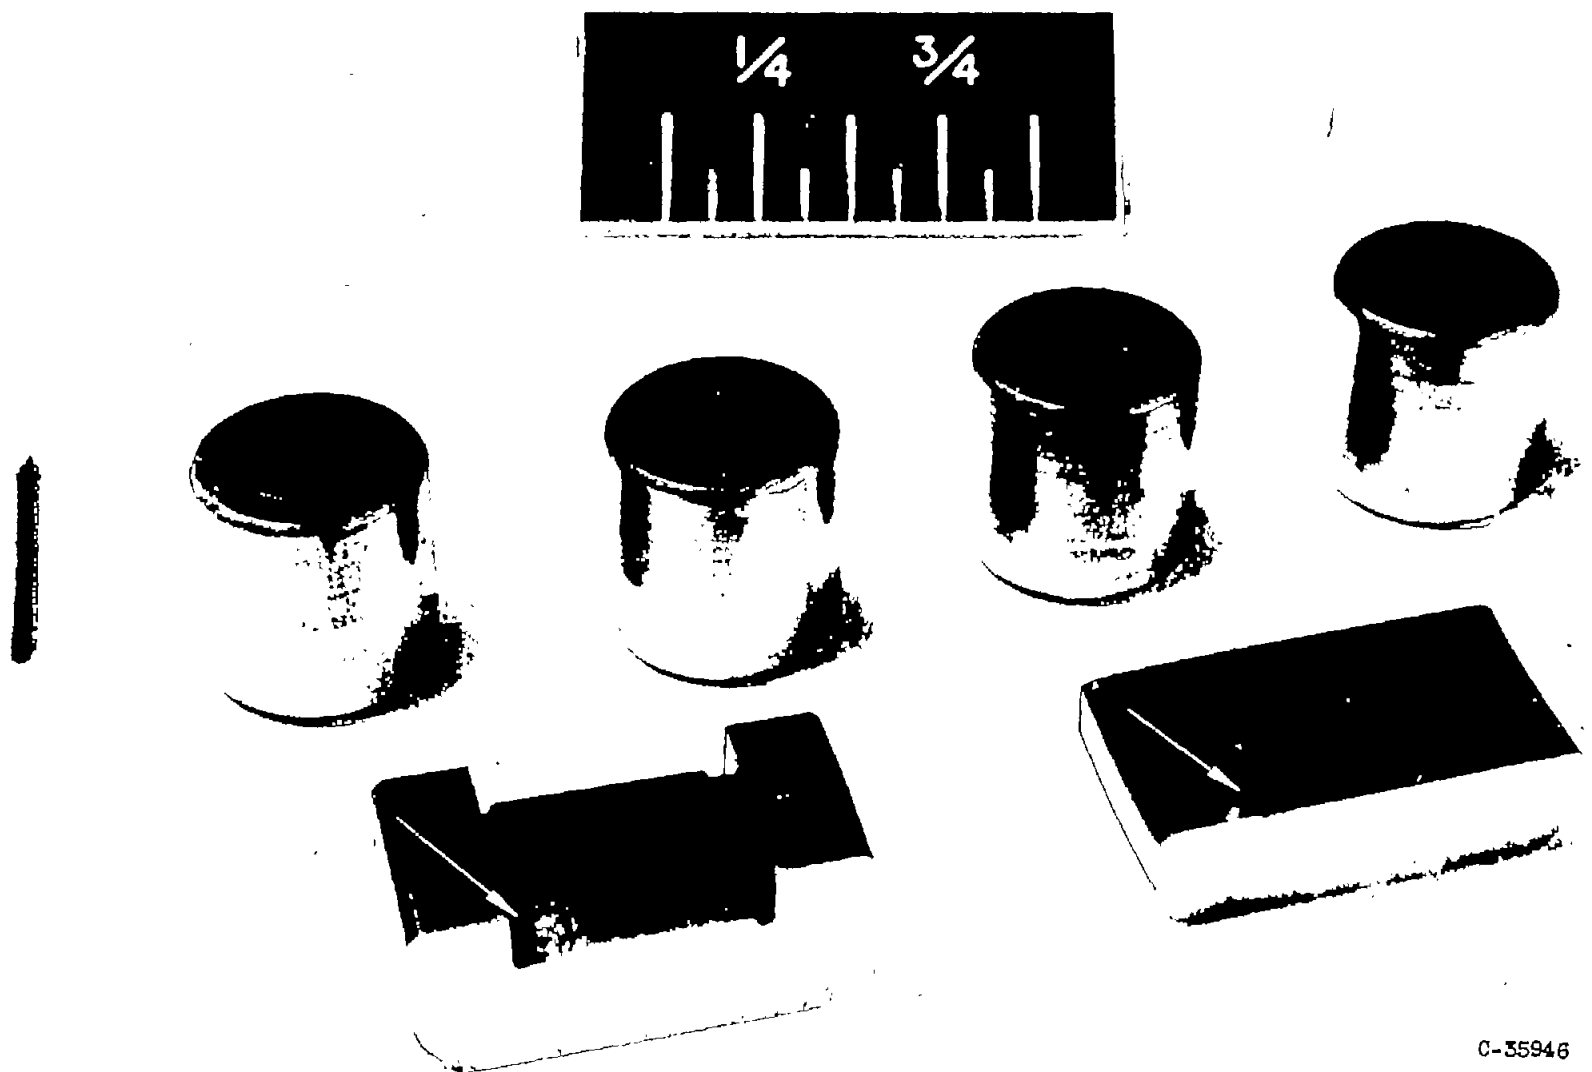
Figure 14. - Cylindrical roller bearing that failed because of misaligned load.
